Situation Photo Log

Friday, December 28, 2012

Kalamazoo River / Enbridge Spill

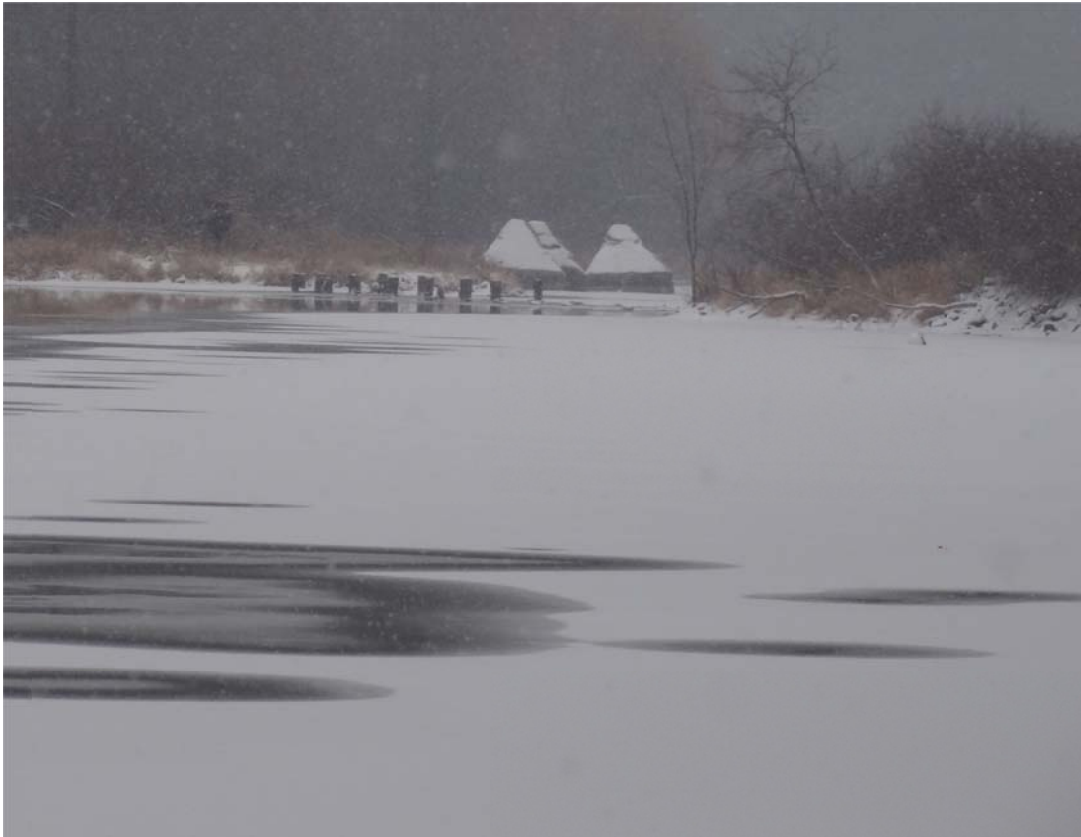
1. MP 5.63 Ceresco Dam trestle, ice and snow cover observed along both river banks. River channel remains open, with some ice and snow observed in channel.

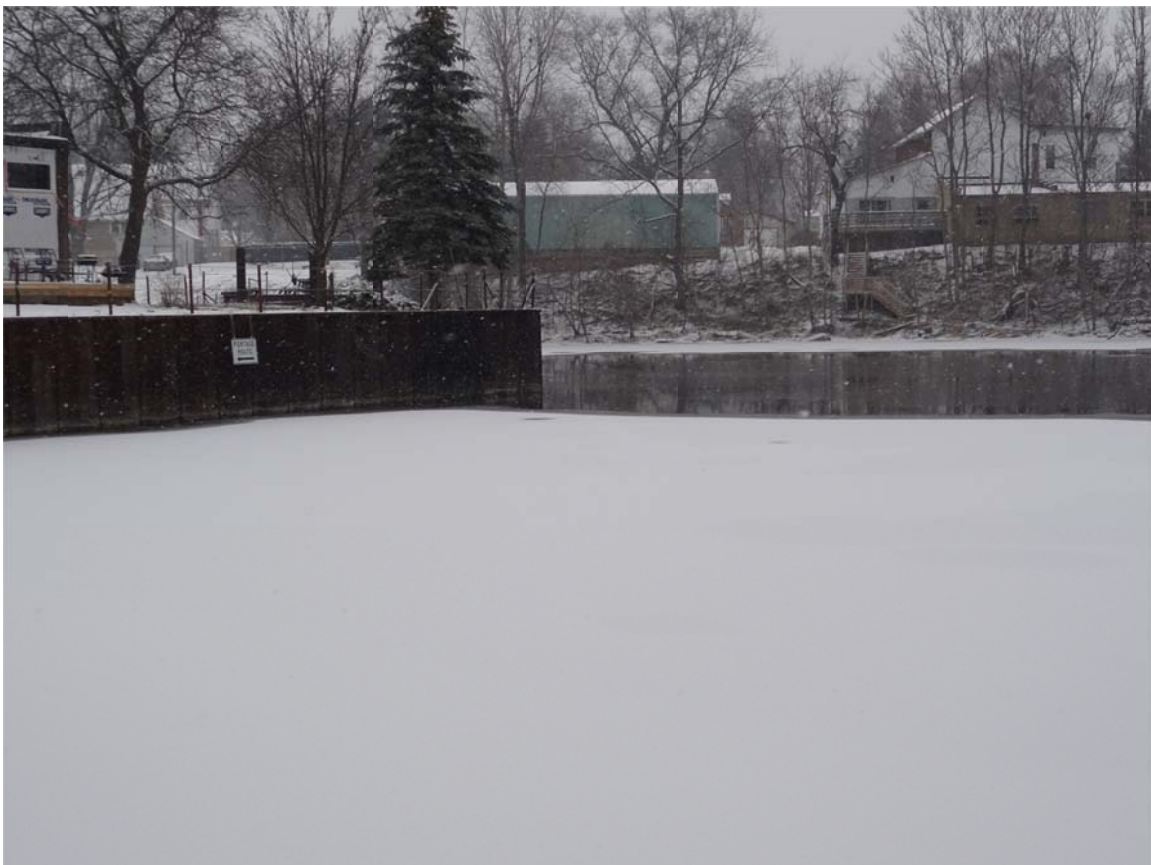
2. Ceresco Dam impoundment, some ice and snow observed flowing downstream in river channel.

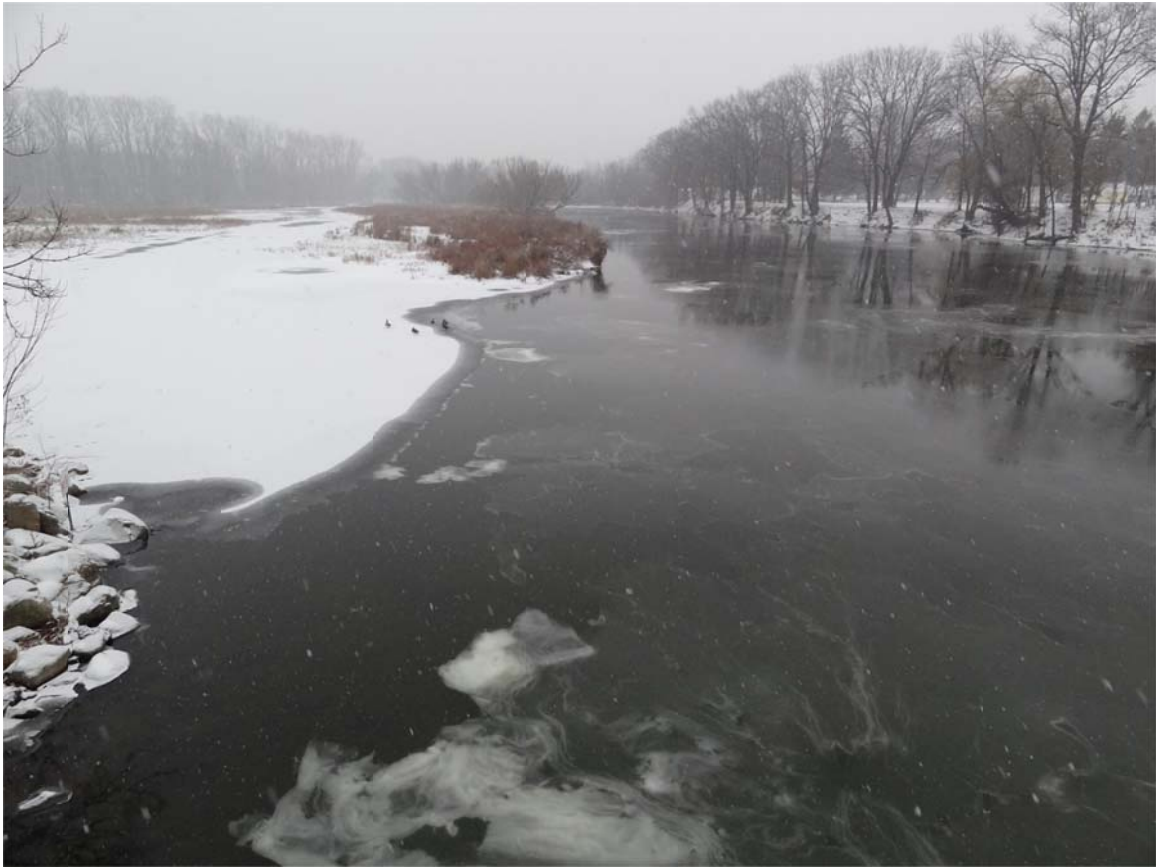
3. MP 15.50 South Mill Pond. Frazil ice observed flowing downstream in river channel.

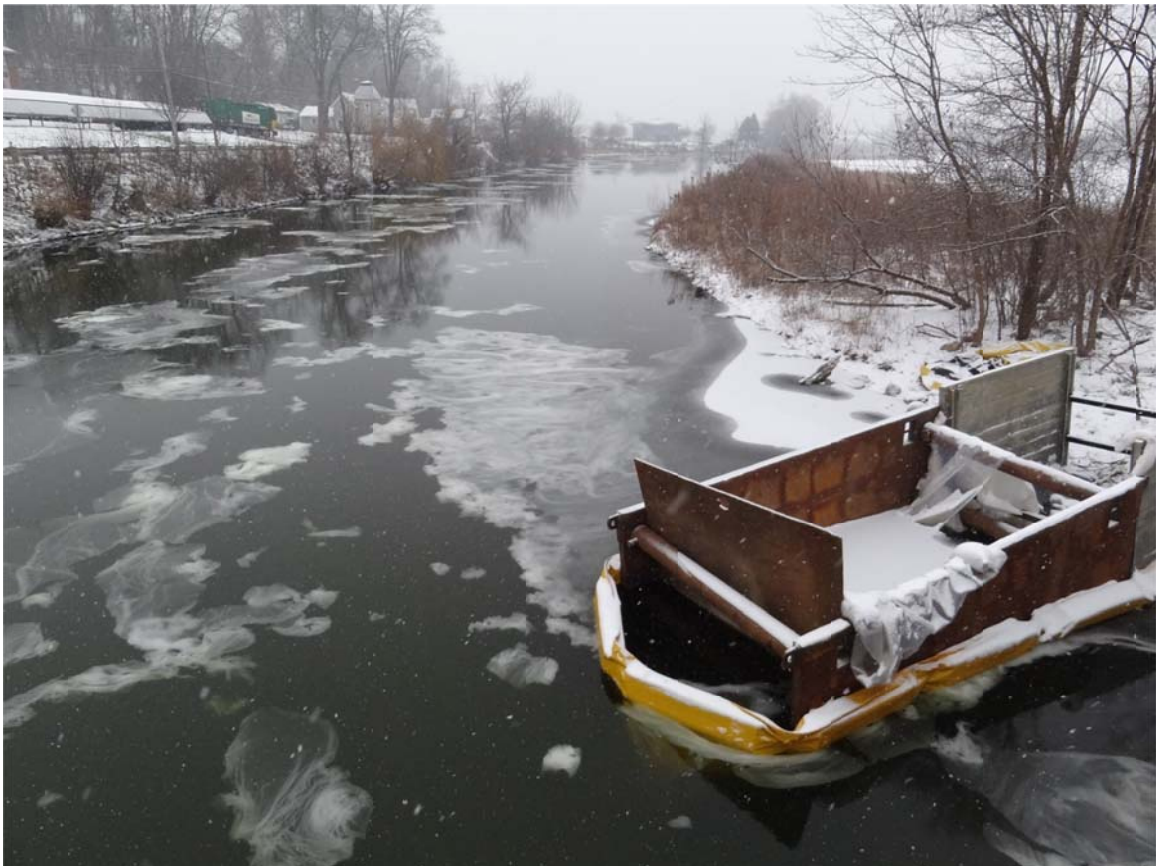
4. MP 15.5 North Mill Pond, frazil ice observed.

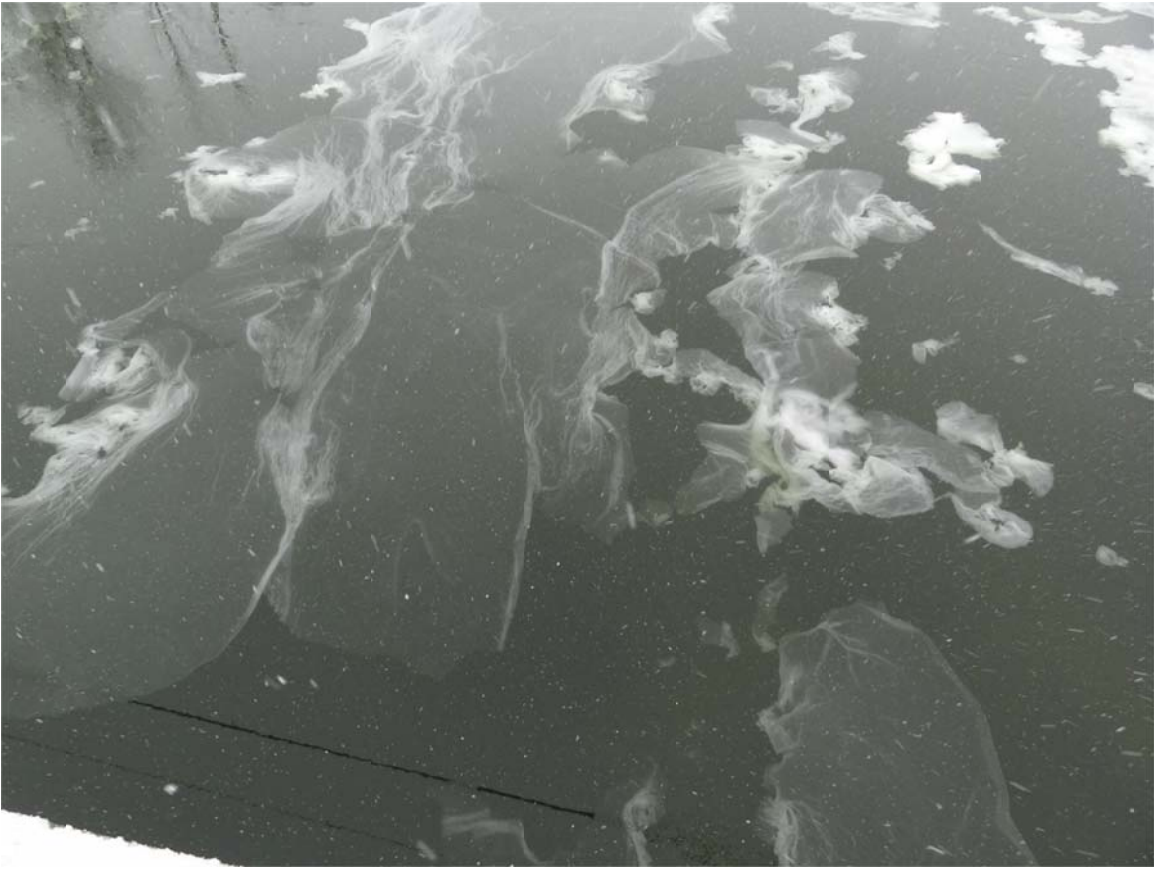
5. MP 15.5, close-up of frazil ice in river channel below Burnham Street Bridge.

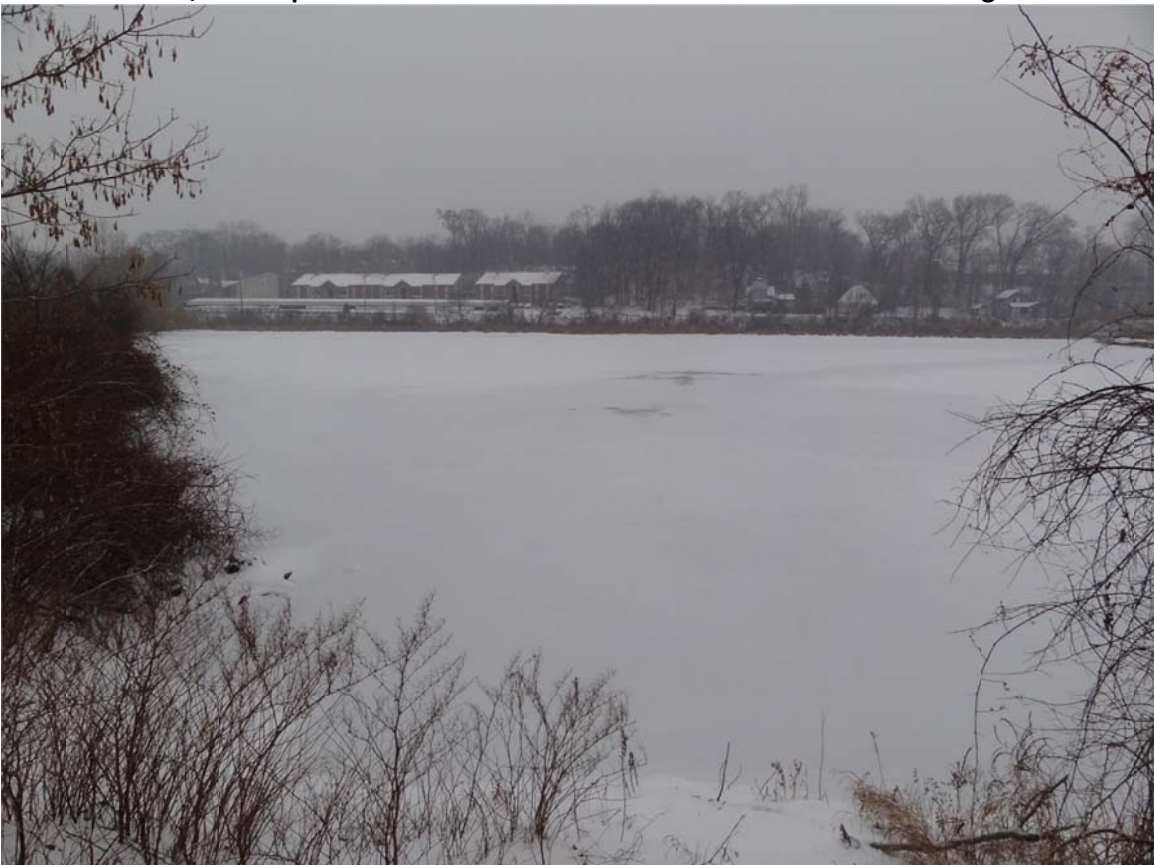
6. MP 15.50 eastern portion of North Mill Pond. Back water area covered with ice and snow. No sheen observed.

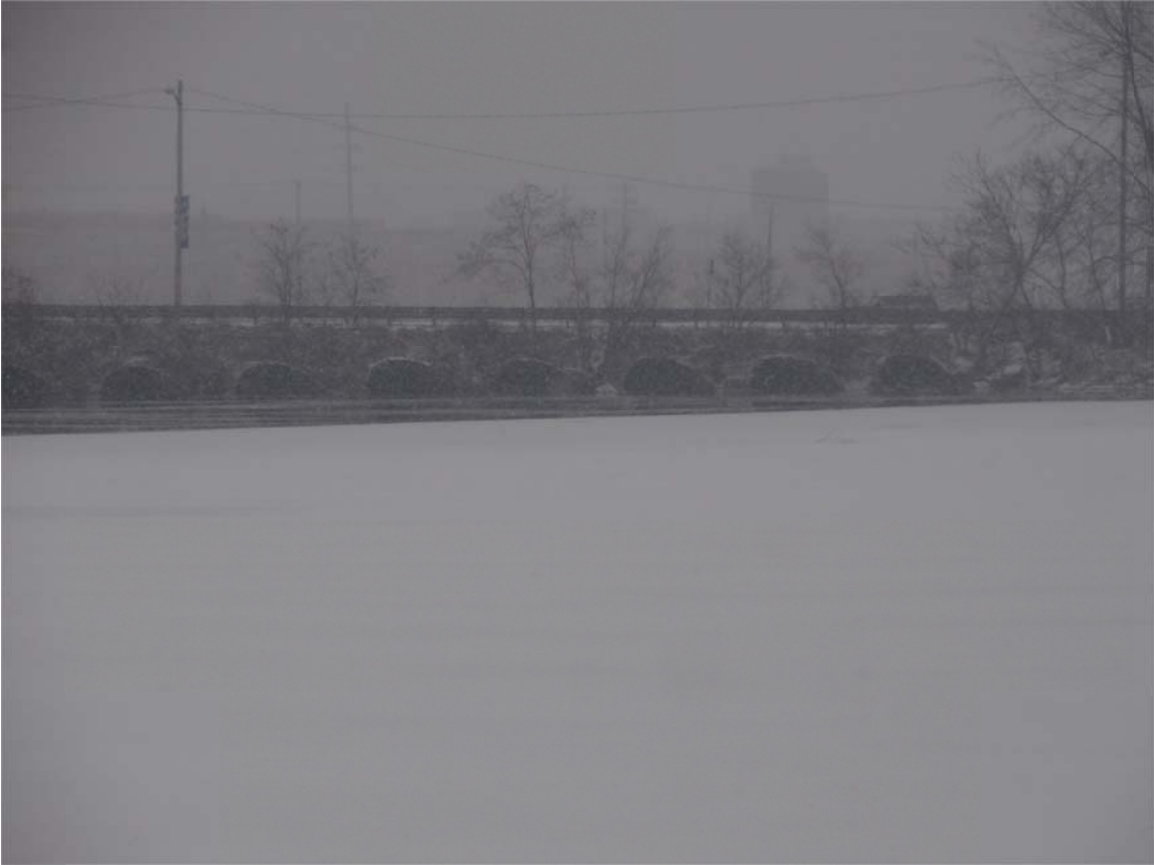
7. MP 15.75 North Mill Pond culverts, frazil ice observed in river channel.

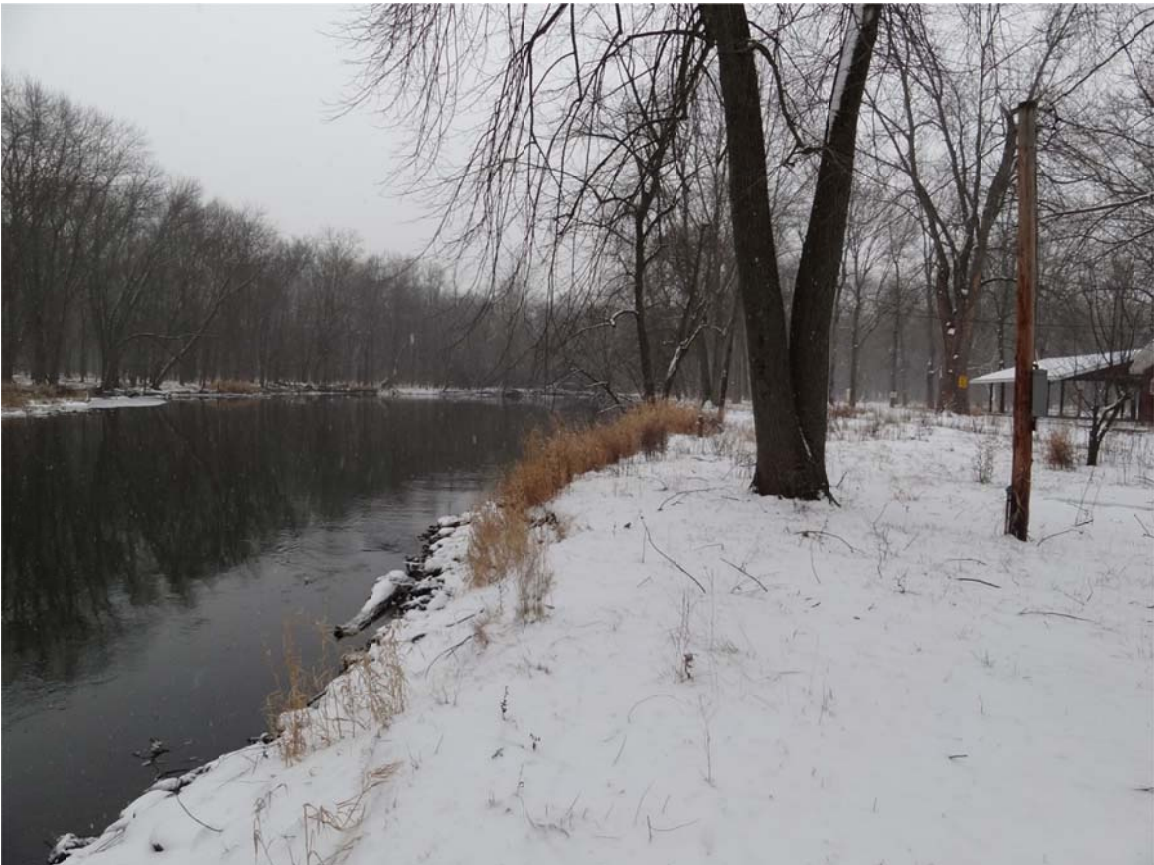
8. MP 27.0 Shady Bend Campground. Only minor bank ice observed.

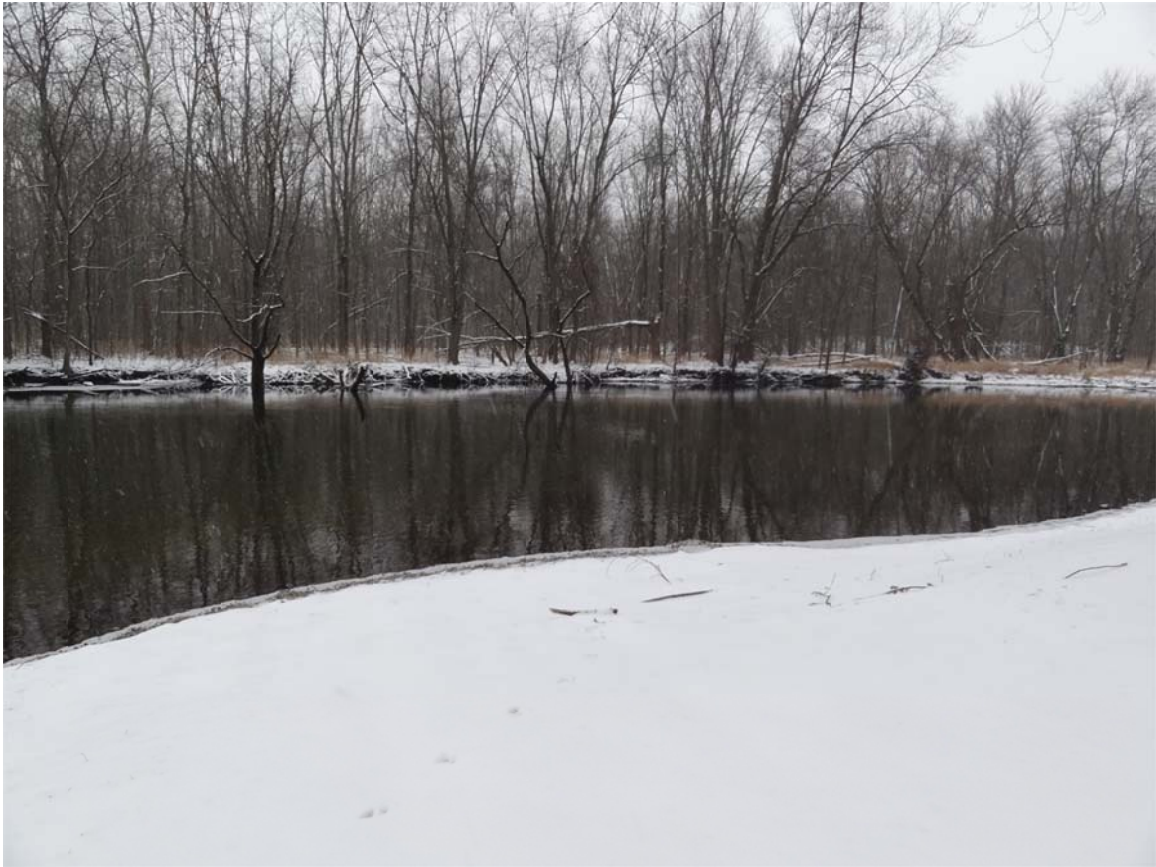
9. MP 27.0 Shady Bend Campground boat launch. Only minor bank ice observed.

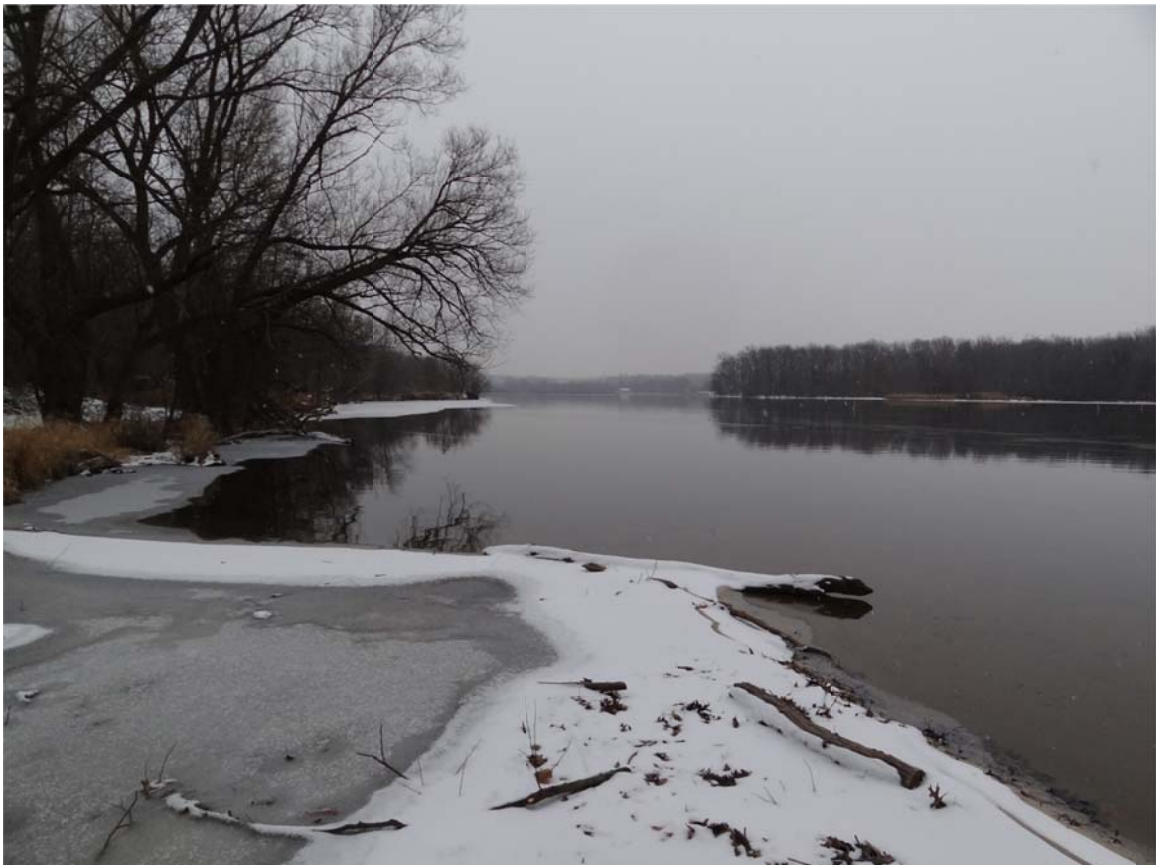
10. Former E4.0 boom location looking east into delta. Ice observed along banks.

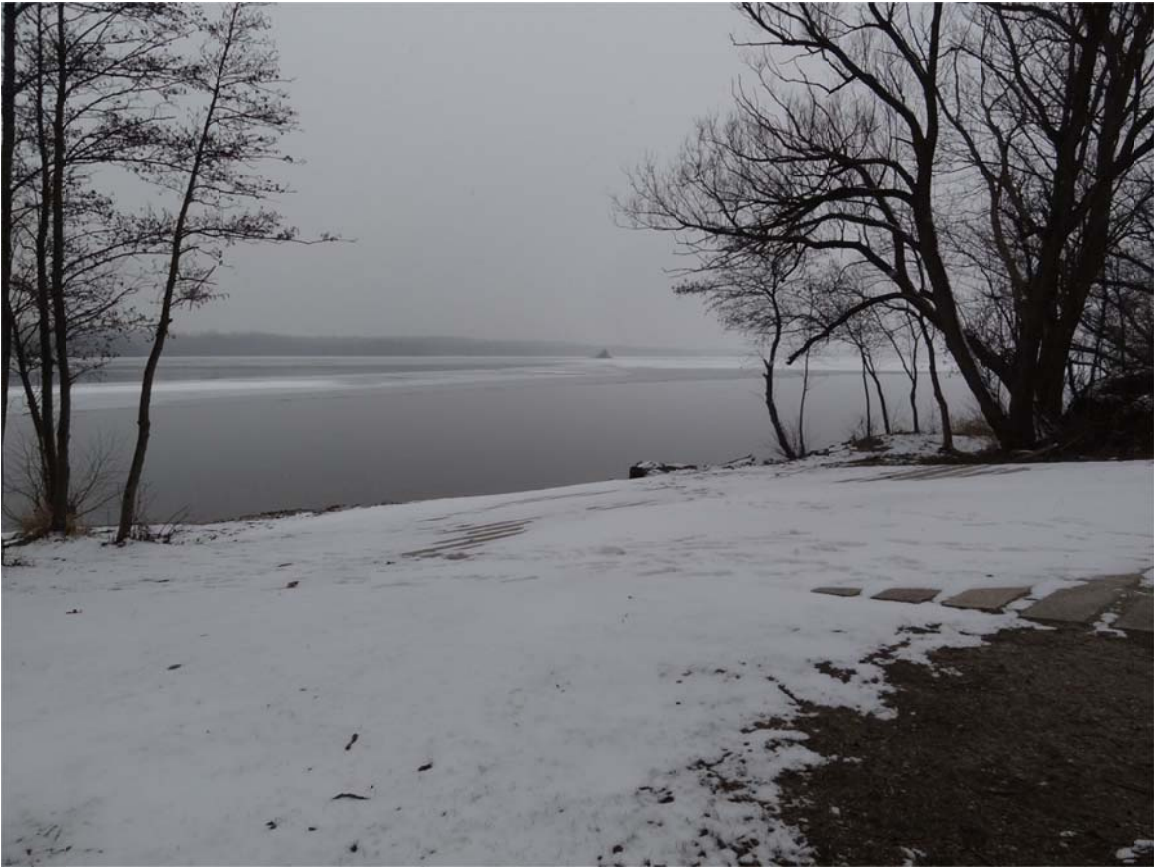
11. E4.0 boat launch. Snow and ice observed across south cove of Morrow Lake.

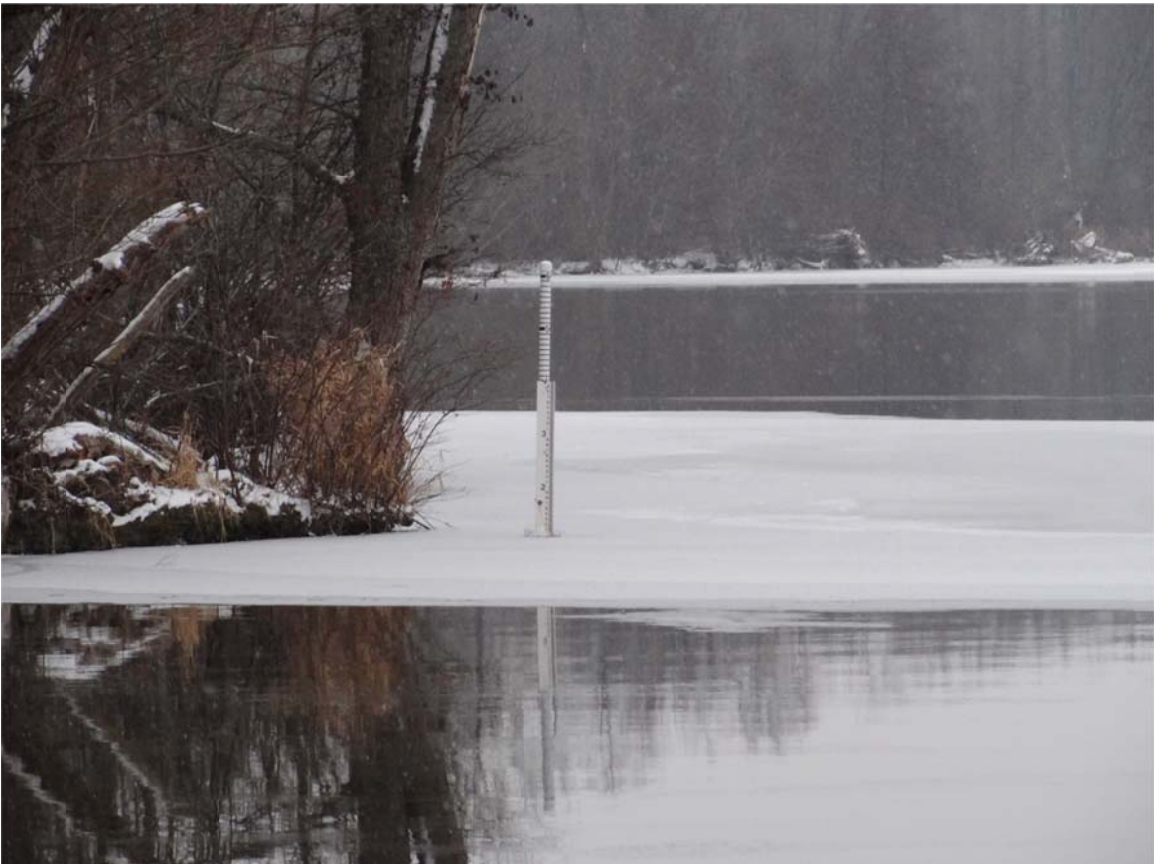
12. E4.0 boat launch, river gauge in ice south of E4.0 boat launch.

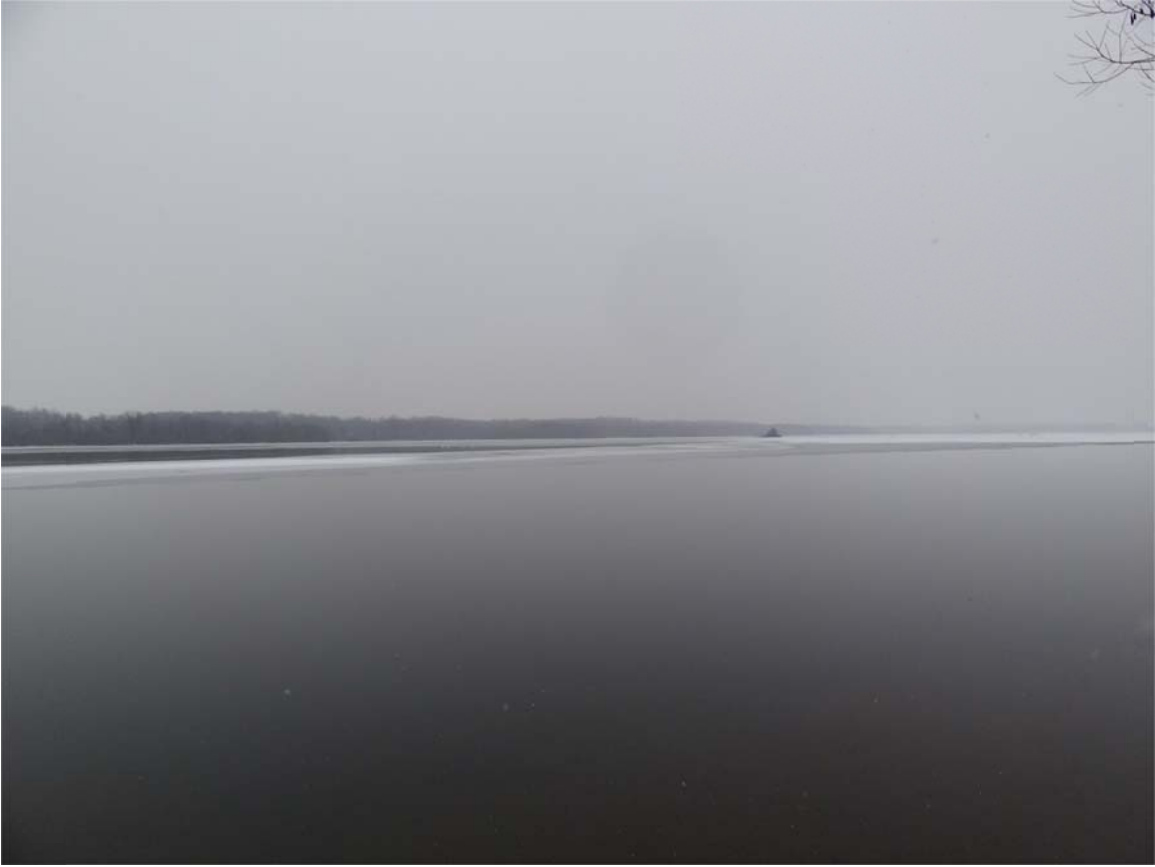
13. View of Morrow Lake looking southwest. West end of Morrow Lake and south cove appear to be covered in ice.

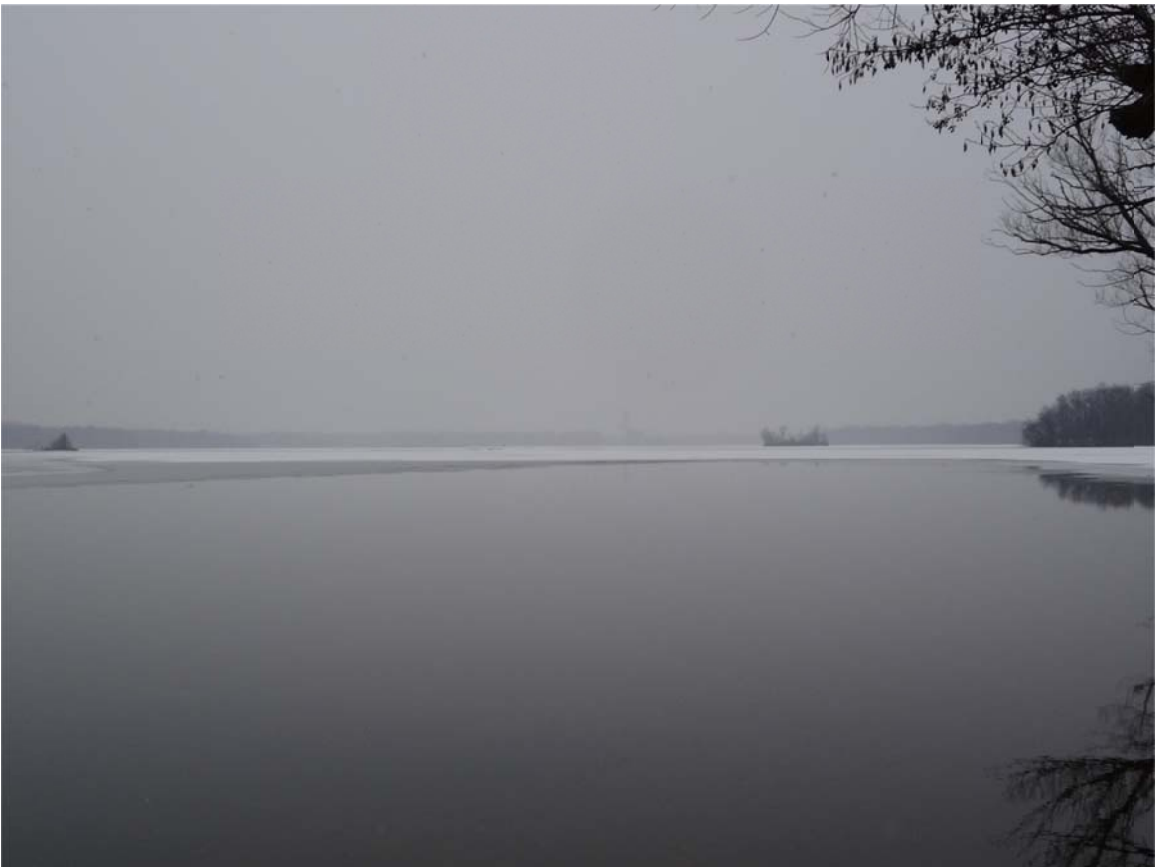
14. West end of Morrow Lake and north cove appear to be covered in ice.
